Product Change Notification / SYST-04AEAI643

ERRATA - dsPIC33EPXXXGS70X/80X Family Silicon Errata and Data Sheet Clarification

dsPIC33EPXXXGS70X/80X Family Silicon Errata and Data Sheet Clarification

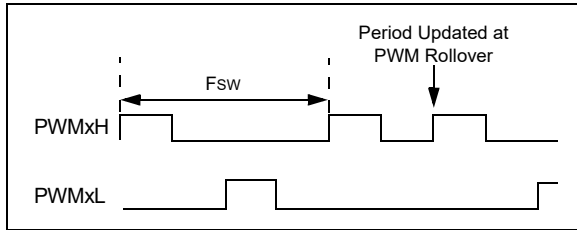
FIGURE 1:

When the PWM module is configured for Push-Pull mode (IOCONx[11:10] = 0b10) with the Enable Immediate Period Update bit enabled (PTCON [10] = 1), a write to the Period register that coincides with the period rollover event may cause the push-pull output logic to produce back-to-back pulses on the PWMx pins (see Figure 1).

Ensure that the update to the PWM Period register occurs away from the PWM rollover event by setting the EIPU bit (PTCON[10] = 1). Use either the PWM Special Event Trigger (SEVTCMP) or the PWM Primary Trigger (TRIGx) to generate a PWM Interrupt Service Routine (ISR) near the start of the PWM cycle. This ISR will ensure that period writes do not occur near the PWM period rollover event.

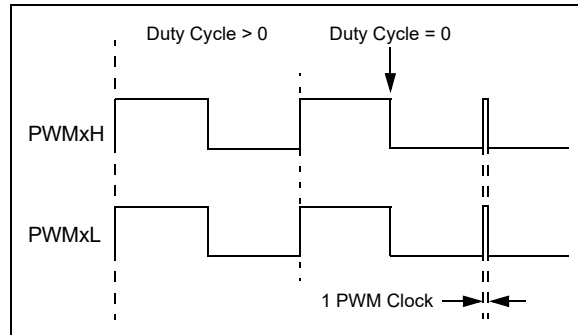
FIGURE 2: EXAMPLE FOR REDUNDANT OUTPUT MODE

In the Redundant Output mode (IOCONx[11:10] = 0b01) and Push-Pull Output mode (IOCONx[11:10] = 0b10), with the Immediate Update Enable bit disabled (PWMCONx[0] = 0), when the Duty Cycle register is updated from a non-zero value to zero, a glitch pulse of a width equal to 1 PWM clock will appear at the next PWM period boundary, as shown in Figure 2 (for the Redundant Output mode). The Duty Cycle register refers to the PDCx register if PWMCONx[8] = 0 or the MDC register if PWMCONx[8] = 1.

If the application requires a zero duty cycle output, there are two possible work around methods:

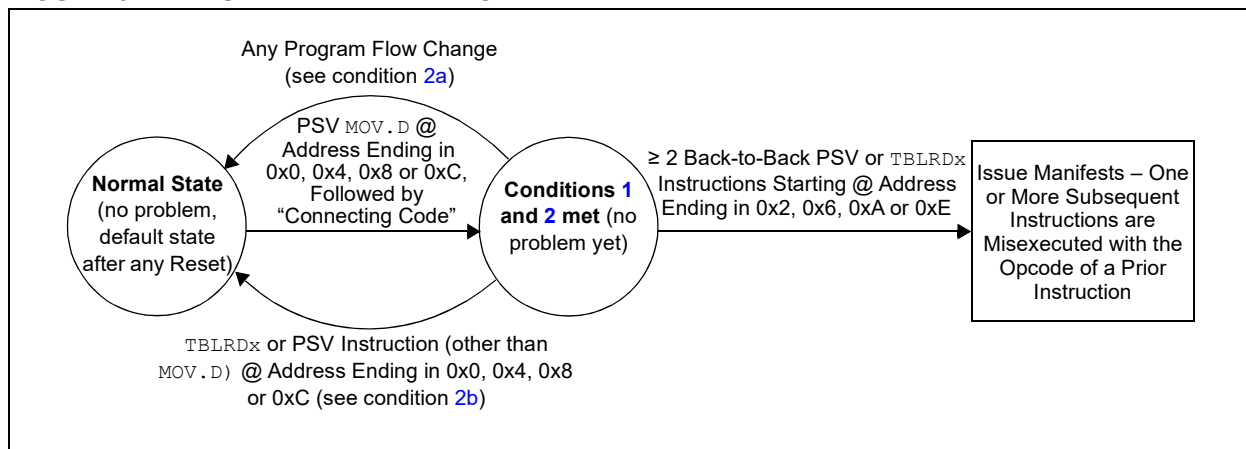
FIGURE 3: SIMPLIFIED BEHAVIOR

When two or more data Flash read instructions (via Program Space Visibility (PSV) read or Table Read) are executed back-to-back, one or more subsequent instructions can be misexecuted when all of the conditions in [Table 4](#) occur.

1. A PSV <code>MOV.D</code> instruction is executed, with opcode at address ending in 0x0, 0x4, 0x8 or 0xC; and
2. Some “connecting code” is executed (following the <code>MOV.D</code> of condition 1), with the properties: <ul style="list-style-type: none"> a) The connecting code does not include any program flow changes, including: taken branch instructions (including all versions of <code>BRA</code>, <code>CPBEQ</code>, <code>CPBGT</code>, <code>CPBLT</code>, <code>CPBNE</code>), <code>CALL</code>, <code>CALL.L</code>, <code>GOTO</code>, <code>GOTO.L</code>, <code>RCALL</code>, <code>RETLW</code>, <code>RETURN</code>, vectoring to an ISR, returning from an interrupt (<code>RETFIE</code>) and certain debug operations, such as break and one-step; and b) The connecting code does not include a <code>TBLRDx</code> or non-<code>MOV.D</code> PSV instruction, located at a Flash memory address ending in 0x0, 0x4, 0x8 or 0xC; and c) The connecting code is at least two instruction words in length; and d) The connecting code does not end with a <code>REPEAT</code> instruction, with count > 0; and

3. ≥ 2 back-to-back PSV or <code>TBLRDx</code> instructions are executed (following the code of condition 2), where the first of the back-to-back instructions is located at an address ending in 0x2, 0x6, 0xA or 0xE.

[Figure 3](#) provides an example of the effective behavior.

The issue can be avoided by ensuring any one or more of the requirements are not met. For example:

1. All instances of PSV `MOV.D` can be replaced with two PSV `MOV` instructions instead. Non-PSV `MOV.D` instructions acting on RAM/SFRs do not need to be modified; or
2. If not already present, a program flow change instruction (such as `BRA $+2`) can be inserted above back-to-back data Flash read sequences; or
3. Back-to-back data Flash read instruction sequences can be broken up by inserting a non-Flash read instruction (such as a `NOP`), in between the Flash read instructions; or
4. The alignment of the code can be shifted to avoid the required opcode location addresses.

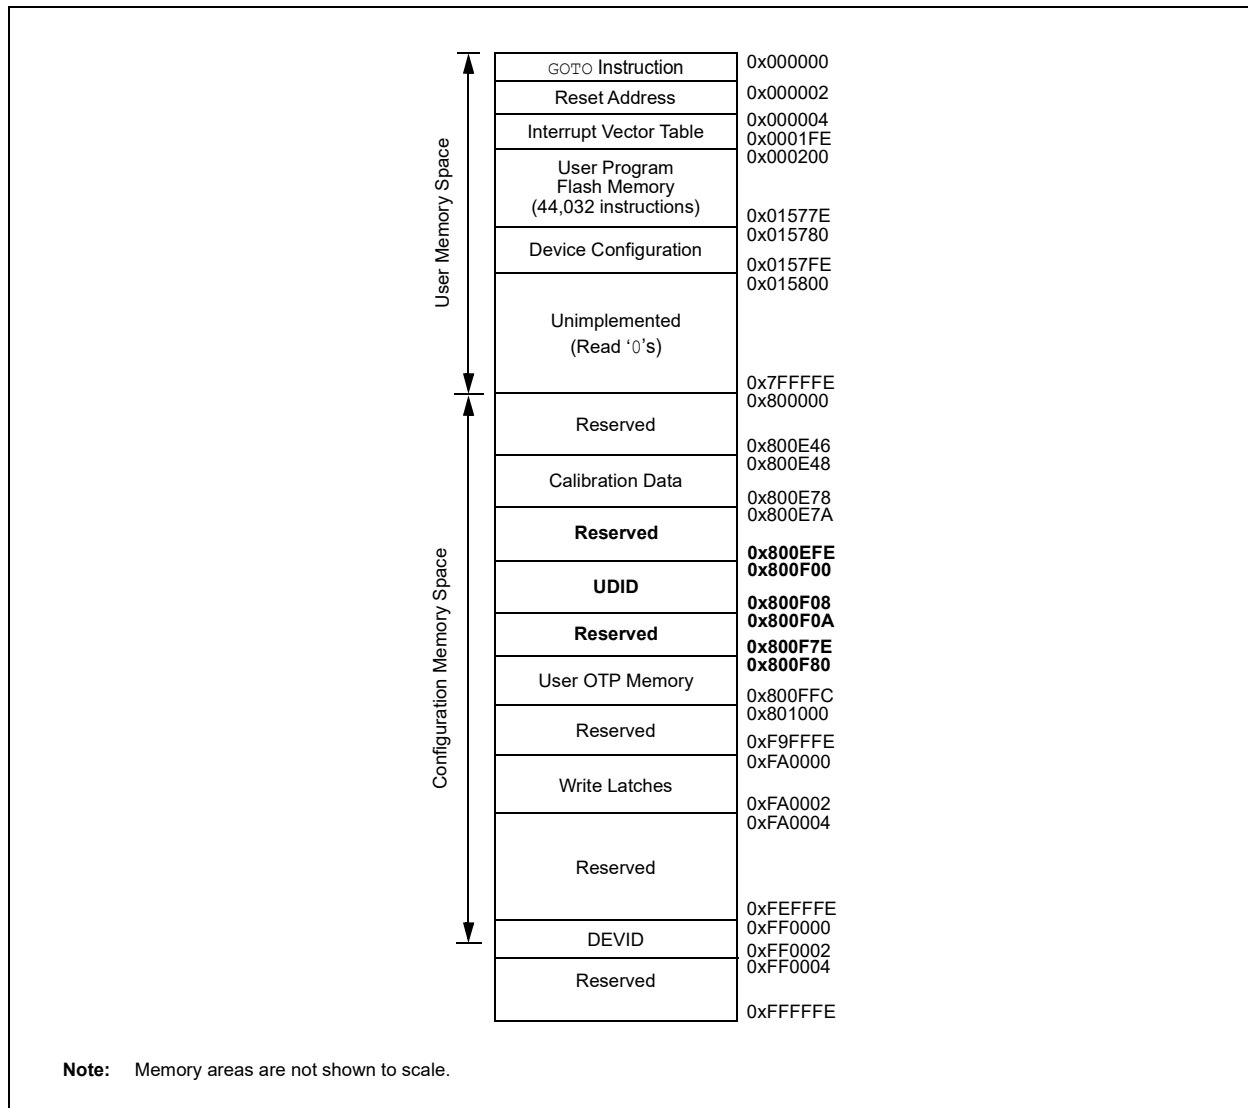
FIGURE 4-2: PROGRAM MEMORY MAP FOR dsPIC33EP128GS70X/80X DEVICES

In Figure 4-2, the following changes have been made as shown in **bold**:
