Product Change Notification / SYST-11QMDW332

ERRATA - KSZ9477S Silicon Errata and Data Sheet Clarification

KSZ9477S Silicon Errata and Data Sheet Clarification

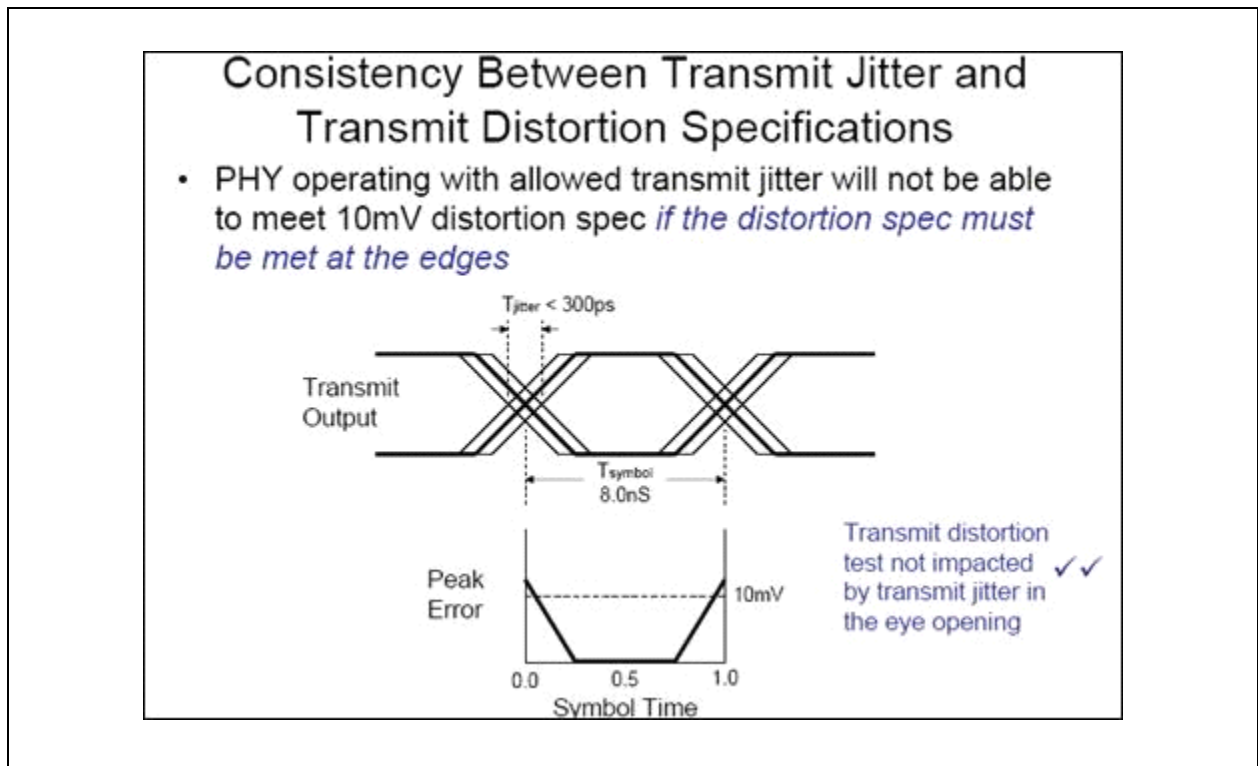
FIGURE 1: IEEE DOCUMENT PAGE 6

It is unlikely this specification failure will impact system performance. The following link to the Gigabit Transmit Distortion Testing document on the IEEE802.org website also questions the validity of this measurement:

- On page 6, a contradiction between Transmit Jitter and Transmit Distortion requirements:
